Task 5 Final Report: Town of Belleair - Bluff Restoration and Erosion Abatement

May 30, 2025

Owner's Contract Number: ADM22-01

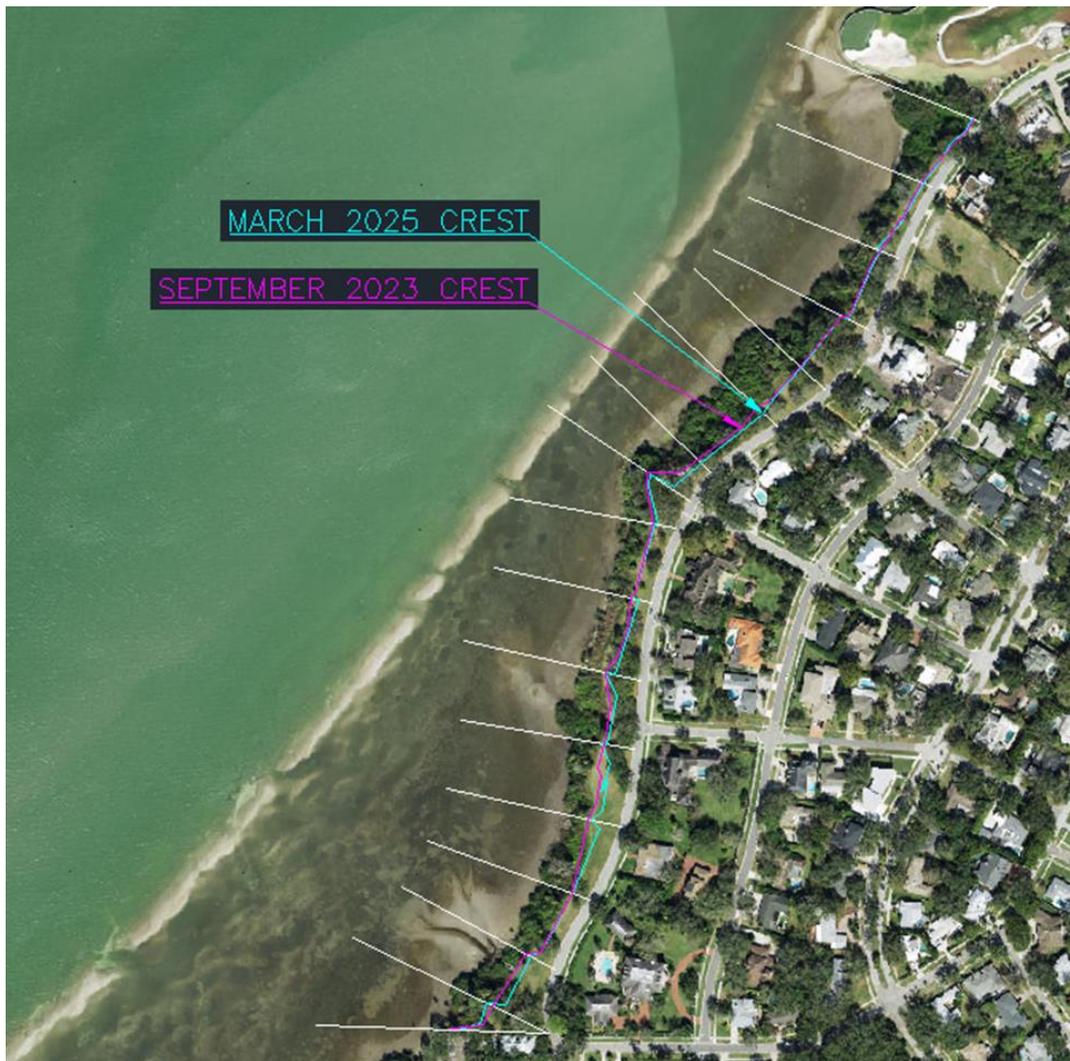
Figure 1: Surveyed Bluff Crest Lines from September 2023 (pink) vs March 2025 (blue)

A review of historical aerial imagery and previous topographic surveys reveals a clear trend of shoreline retreat and bluff erosion over the past decades. APTIM performed topographic surveys of the bluff in November 2023 and March 2025, using 17 transects spaced 200-ft apart along the bluff (**Figure 1**). The pink line in **Figure 1** signifies the bluff crest in 2023 and blue line denotes the bluff crest in March 2025. Although minor areas of accretion were observed, the bluff crest has receded inland by approximately 6–8 feet in certain locations, equating to an average erosion rate of roughly 3.5 feet per year. **Figure 2** overlays the 1997 shoreline (depicted by the yellow solid line) and the 2023 surveyed bluff crest (green line) onto a 1997 historical aerial image. A visual comparison between the 1997 and 2025 shoreline positions clearly illustrates significant inland retreat along the Hallett Park shoreline. These erosional trends reflect the ongoing influence of coastal processes such as wave action, storm surges, and potential human-induced impacts. If the current rate of retreat continues, it could pose increasing risks to nearby properties and may eventually threaten the structural integrity of Bayview Drive. Continued monitoring through updated topographic surveys, drone imagery, and hydrodynamic modeling will be critical for informing future mitigation and stabilization efforts in the area.

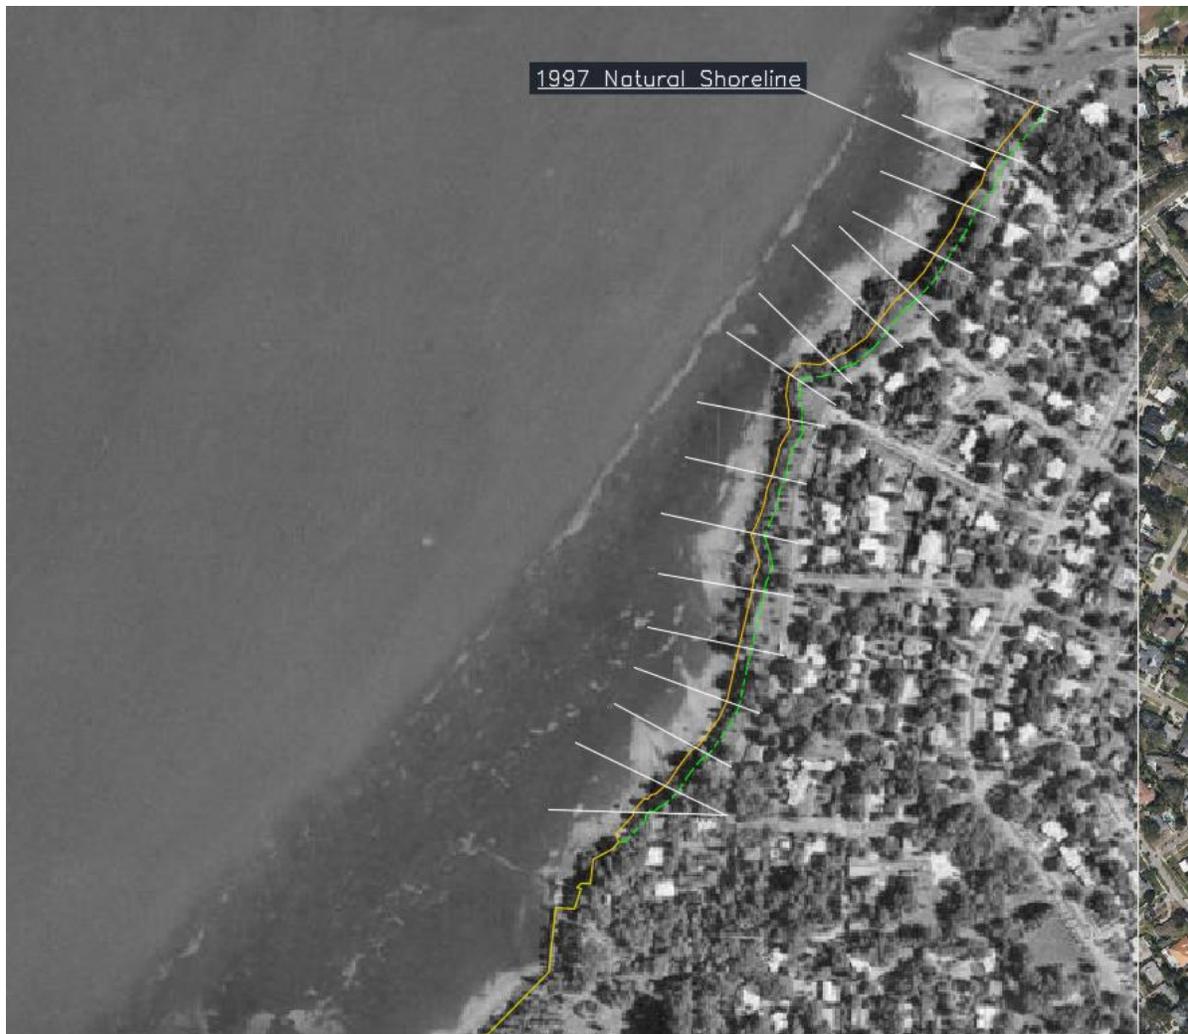
Figure 2: 1997 Historical Bluff Aerial, 1997 Shoreline (yellow line) and 2023 Bluff Crest (green line)

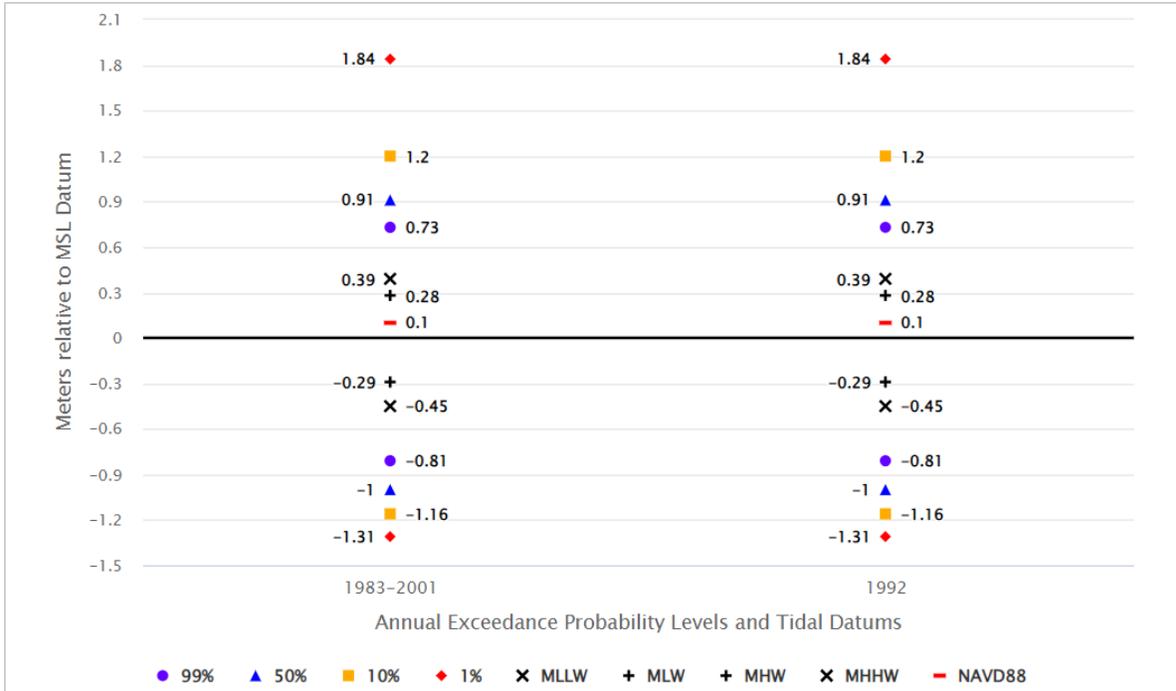
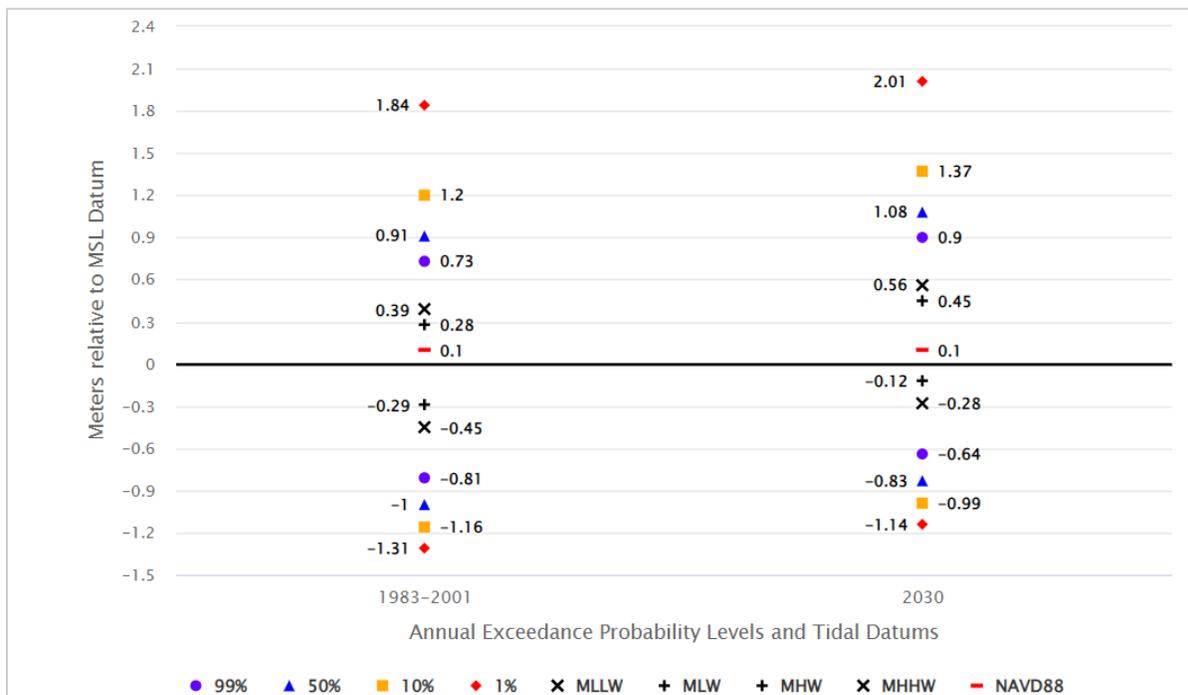
Figure 23: (Station 8726724): 1992 Tidal Datums and Exceedance Probability Levels

Figure 24: (Station 8726724): 2014 Tidal Datums and Exceedance Probability Levels

Figure 25: (Station 8726724): 2024 Tidal Datums and Exceedance Probability Levels

Figure 26: (Station 8726724): 2030 Tidal Datums and Exceedance Probability Levels

Figure 23 - Figure 26 present annual exceedance probability levels relative to tidal datums and the geodetic North American Vertical Datum for 1992, 2014, 2024, and 2030. The left projections show average levels based on the 1983–2001 National Tidal Datum Epoch, while the right projects exceedance probability levels and tidal datums.

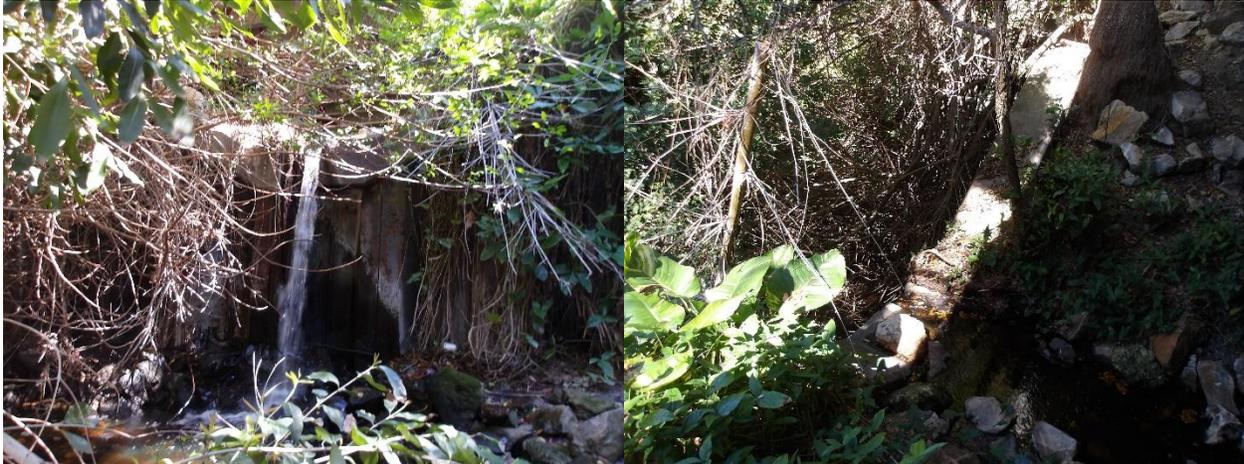
Figure 28. Outfall 1 – Headwall

- OF1, a stormwater conveyance canal between the northern extent of the bluffs in Belleair and the shoreline of the Belleair Country Club Golf Course. As can be seen in **Figure 28**, the evident water quality treatment has been identified to prevent upland pollutants entering and degrading the nearshore waters and ICWW
- OF3, located farther south along the bank of the bluffs in Belleair adjacent to the intersection of Manatee Road and Bayview Drive. The main treatment that this outfall has is the baffle box located just upstream of this outfall.

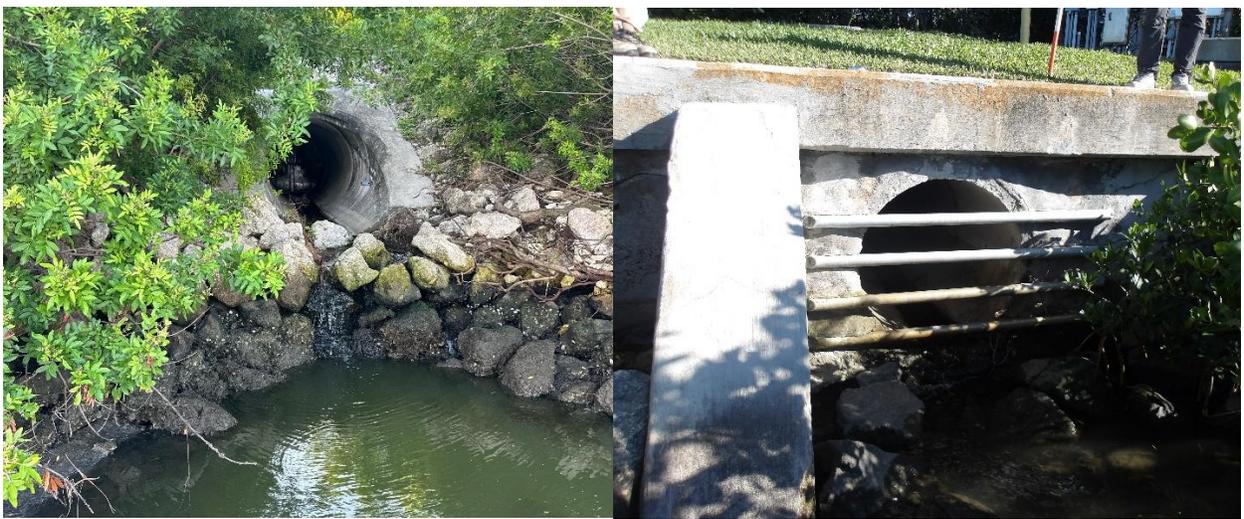
Figure 29. Outfall 3 (Left) and Outfall 4 (Right)

- OF4, located in the southernmost extent of the study area, adjacent to Harborside Drive at the seawall. This outfall is equipped with pipe grates (i.e., debris bars or trash screens) designed to intercept large debris and trash before reaching the ICWW. While effective for capturing solid waste, this treatment offers minimal protection against micro-particles, nutrients, and bacteria that continue to enter and degrade the nearshore waters and the ICWW.

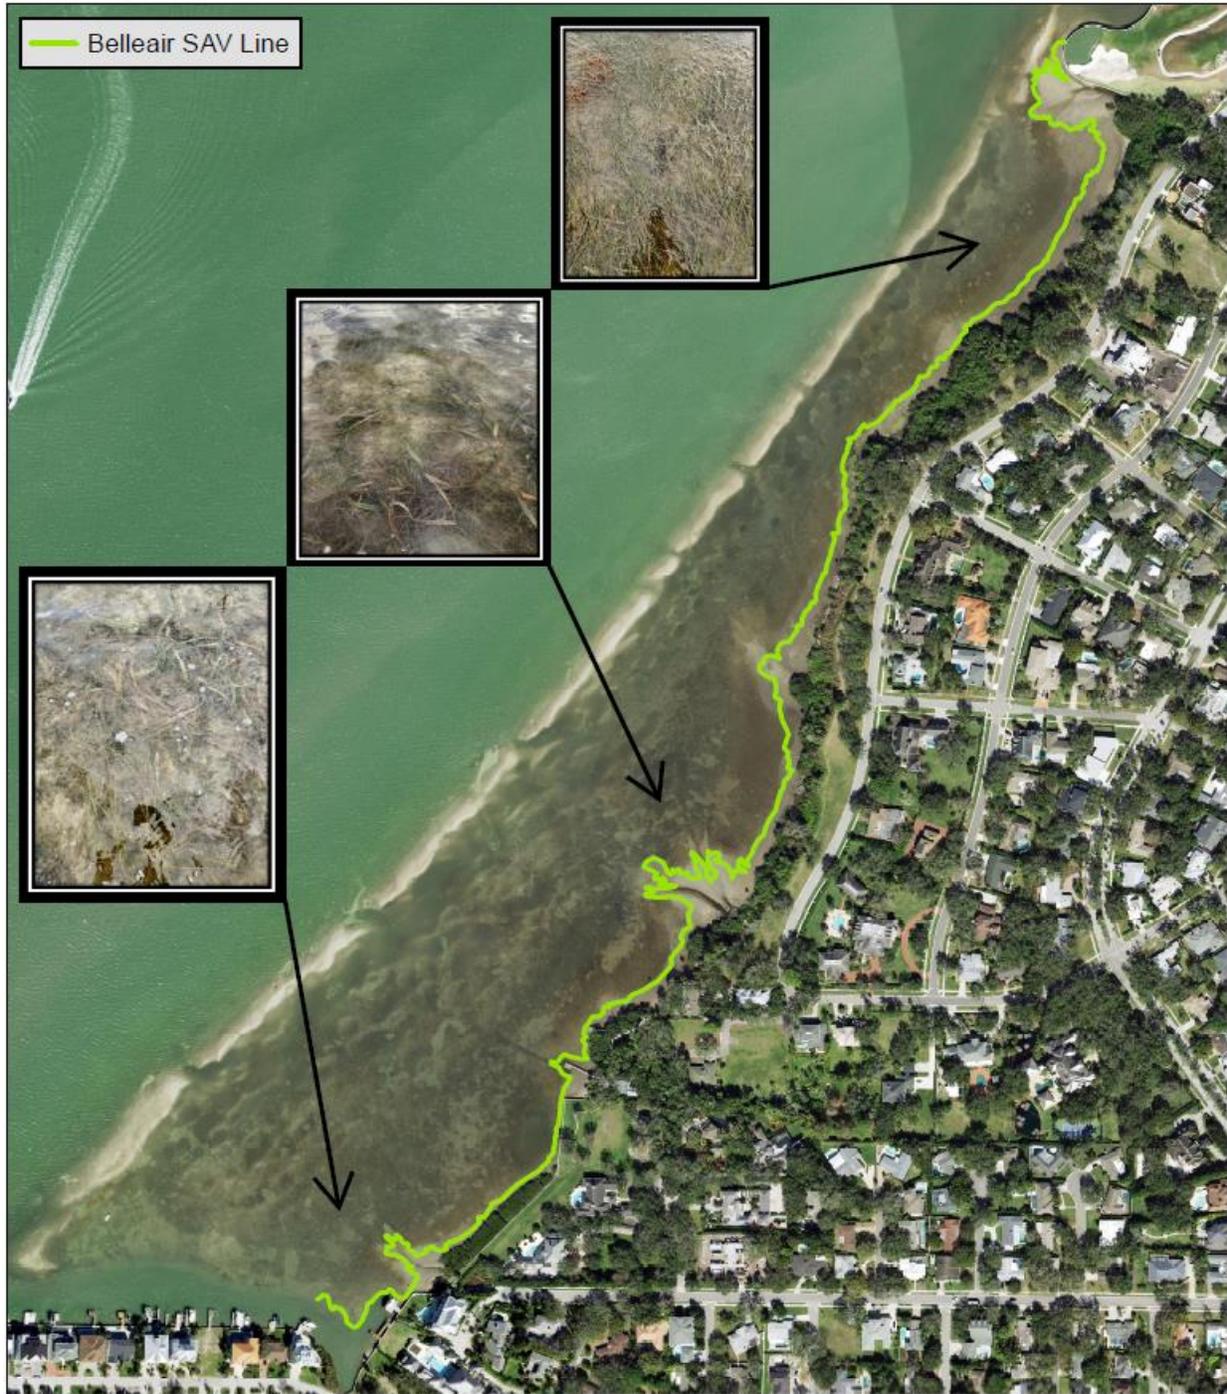
Figure 30: SAV Survey Results

A reconnaissance submerged aquatic vegetation (SAV) survey was conducted on January 11th, 2024. The SAV survey mapped the extent and condition of seagrass beds along the shoreline, identifying variations in species density, blade length, and sediment deposition near outfalls (**Figure 30** and **Figure 31**). Seaward from the shore, shallow grass flats transition from sparse *Halodule wrightii* nearshore to a dense mixture of other seagrass types (*Halodule wrightii*, *Syringodium filiforme*, and *Thalassia testudinum*) in deeper areas. The landward edges of the seagrass bed were precisely delineated using a sub-meter GPS, while photographic documentation was used to capture and emphasize the potential impacts of bluff erosion and stormwater runoff.

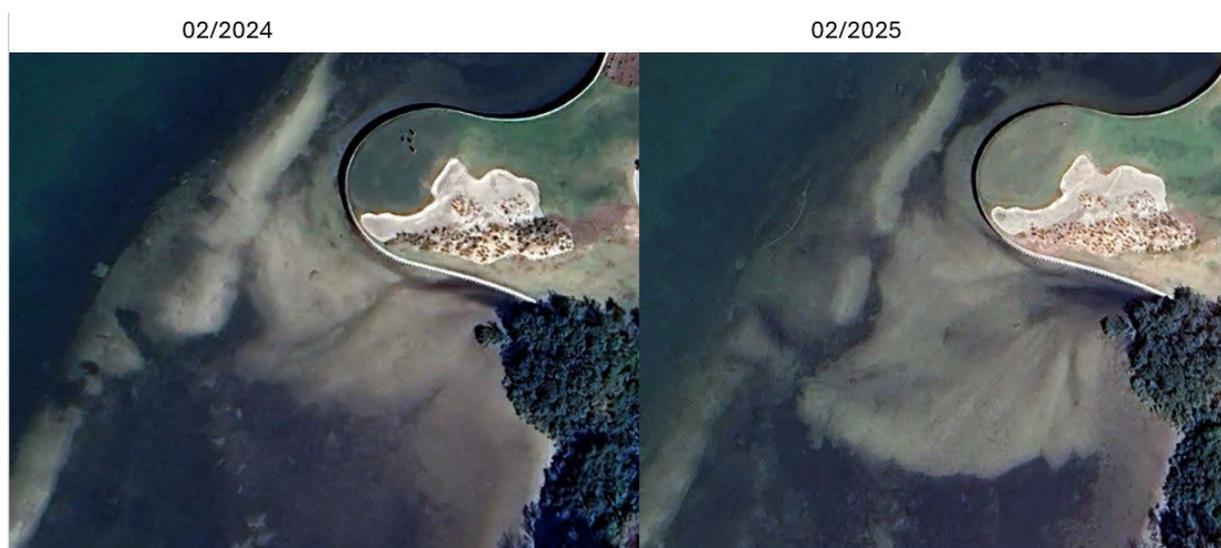
Figure 34. Sand deposition observed from satellite imagery adjacent to OF-1.

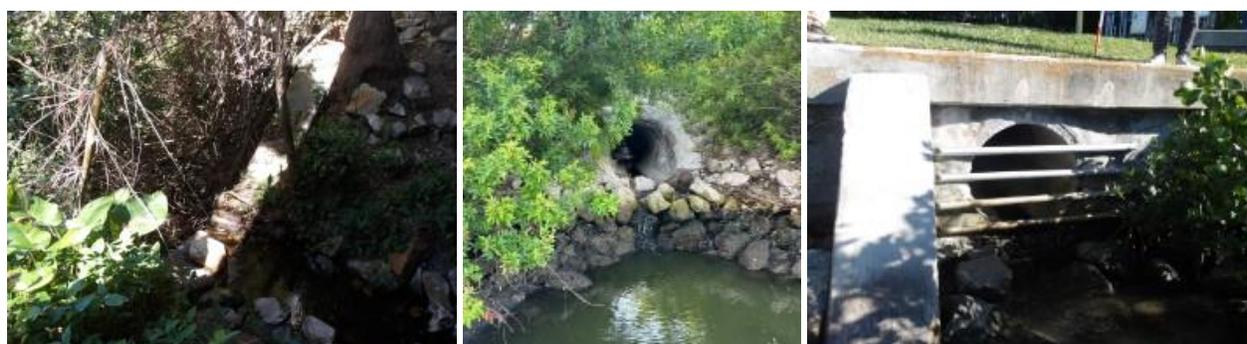
Figure 35. Representative site photograph of stormwater outfalls, OF1, (Left), OF3 (Center) and OF4 (Right)

The method to calculate hydrologic and pollutant loads is described below. Two of the stormwater outfalls (OF3 and OF4) are reinforced concrete pipe, 72” and 36” diameter, respectively. The **estimated discharge** during each monitoring event was calculated using the water level in the outfall pipe at the time of sampling, an estimated slope of 1% and standard Manning’s coefficient for concrete pipe (0.012). Stormwater outfall (OF1) is a weir structure (23 ft) with wing walls (1:1 slope) extending beyond the central straight section with a total length of 53.7 ft. The estimated discharge during each monitoring event at the time of sampling was calculated using a trapezoidal with sloped sides standard equation. The water level above the crest at the time of sampling and an estimated weir coefficient of 3.09 were used to calculate discharge (**Figure 35**).

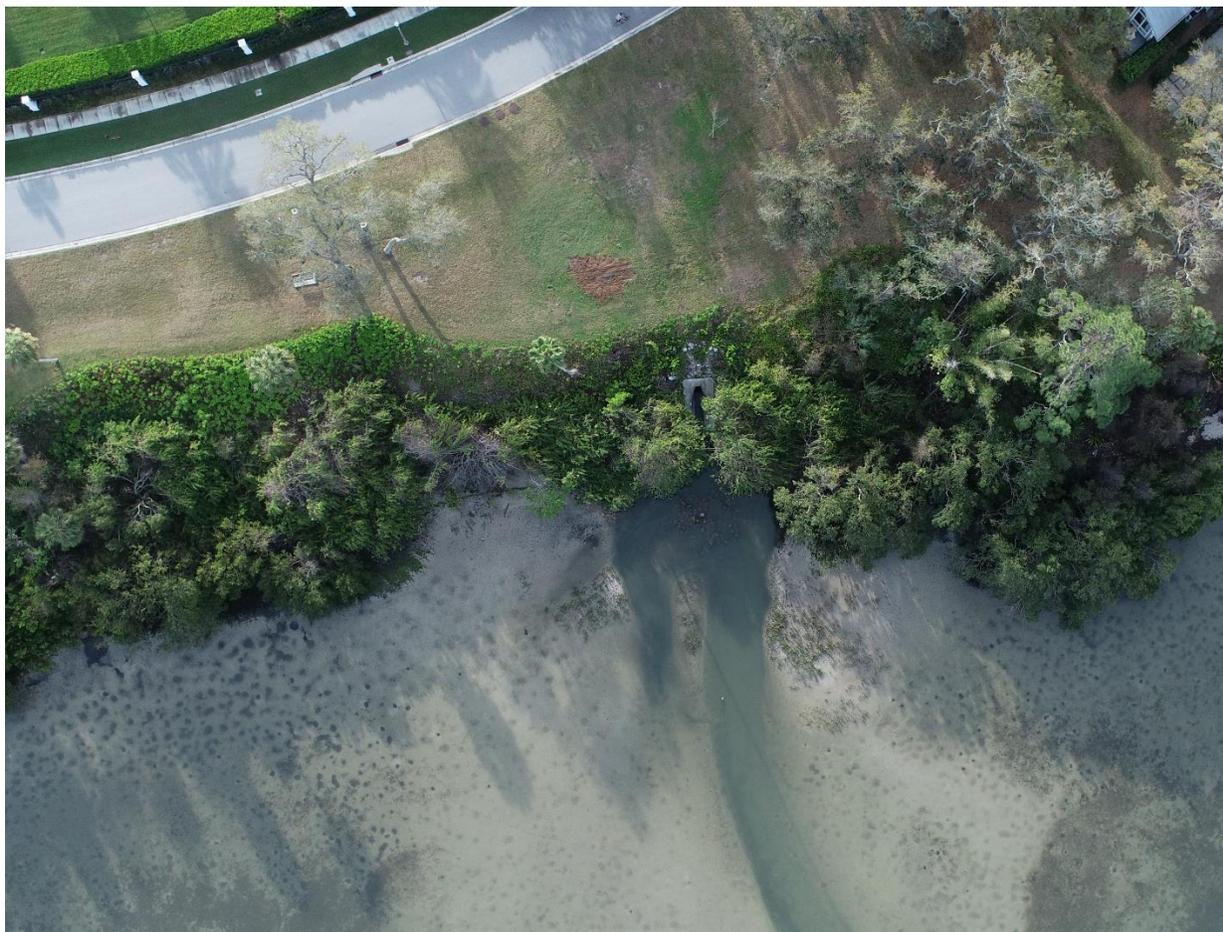
Figure 36. Drone imagery captured by APTIM at Outfall 3 showing visible sediment deposition and bathymetry impact due to stormwater discharge.

In addition, sediment deposition areas are evident adjacent to the stormwater outfalls which impact the substrate and bathymetric conditions that currently support seagrass habitats (**Figure 34 and Figure 36**). The potential impact on water clarity, deposition on existing beds and alteration to the existing suitable site conditions are at risk due to increased sediment deposition. The aerial photography shown in **Figure 34** depicts the sediment deposition in 2024 and 2025. While two major “named” storms directly impacted the site conditions represented in the 2025 imagery, there is evidence prior to these storm events that deposition is persistent adjacent to the outfalls.

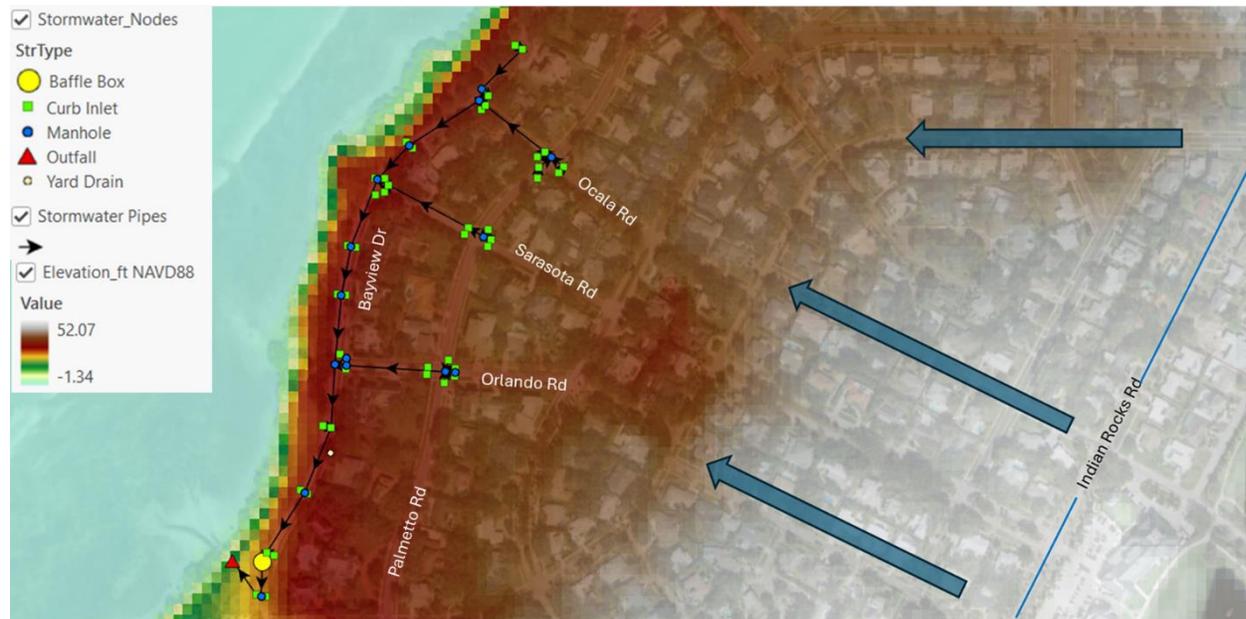
Figure 37. Current drainage network overlaid with Digital Elevation Model indicating flow directions and runoff patterns. Bayview Drive Street and Drainage Improvements project that was completed in 2016 captured and consolidated runoff that was previously discharged through multiple storm outfalls into a single pipe, directing flow to one outfall location (OF3). A stormwater baffle drop box, and an inline sump were installed to dissipate energy and reduce velocities at the outfall. To further reduce the velocity of stormwater discharged into the bay, the inline sump was constructed with the invert elevation of the final outfall pipe slightly above the bottom elevation of the bay. The bluff banks around the new outfall were stabilized with rubble rip-rap.

drainage divide, and stormwater to the west of it is collected via curb and gutter flow, ultimately discharging to ICWW via outfalls along the bluffs in Belleair (**Figure 37**). The drainage area encompasses approximately 117 acres of residential land characterized by sandy soils with high infiltration rates.

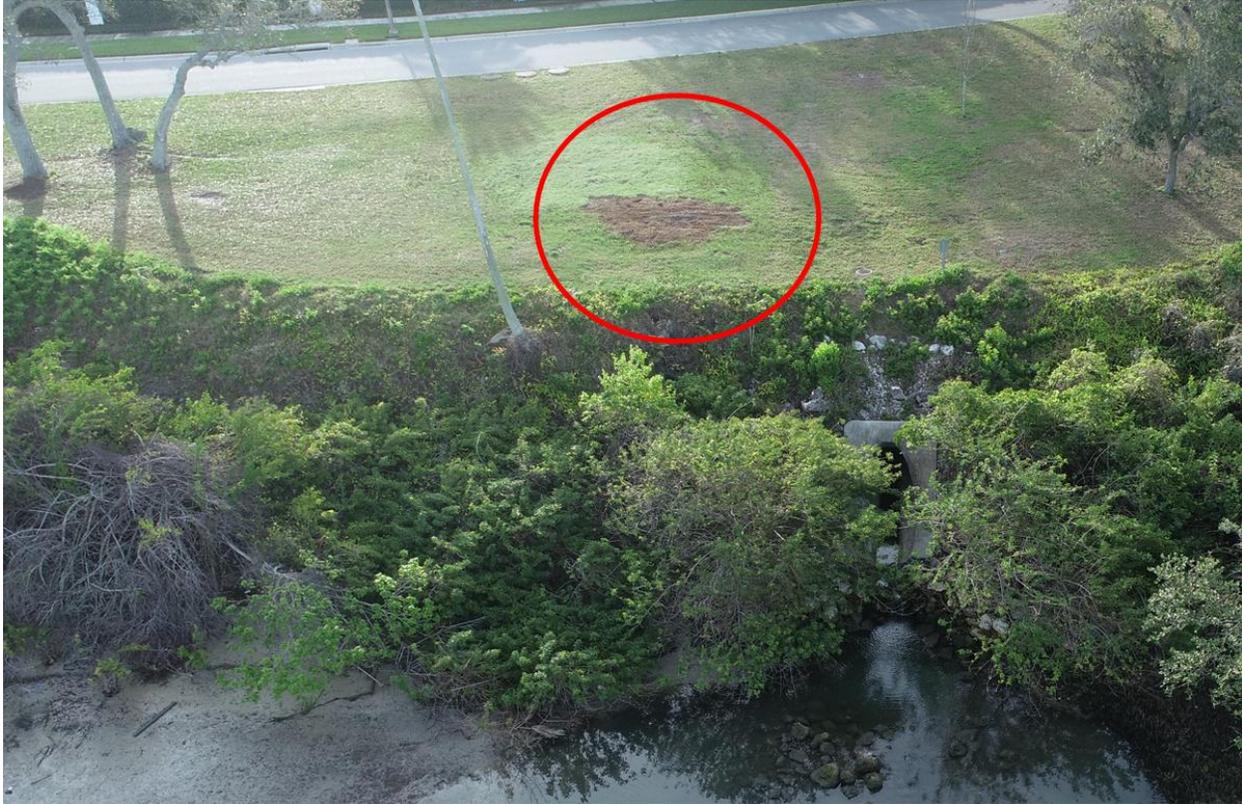
Figure 38. Bare patch of grass on bluff bank near outfall 3

The existing storm outfalls were removed, abandoned, or capped, eliminating erosion and sedimentation at those locations. These improvements provided benefit to the existing seagrasses and mangroves along the shoreline and helped eliminate localized flooding in upstream areas. Despite the best efforts of this project, erosive runoff patterns and water quality issues persists in the study area. **Figure 38** shows an example of bare patches of grass on bluff bank in the vicinity of Outfall 3. This could be an indication of concentrated surface runoff, groundwater seepage or saturation, or a leaky pipe underground.

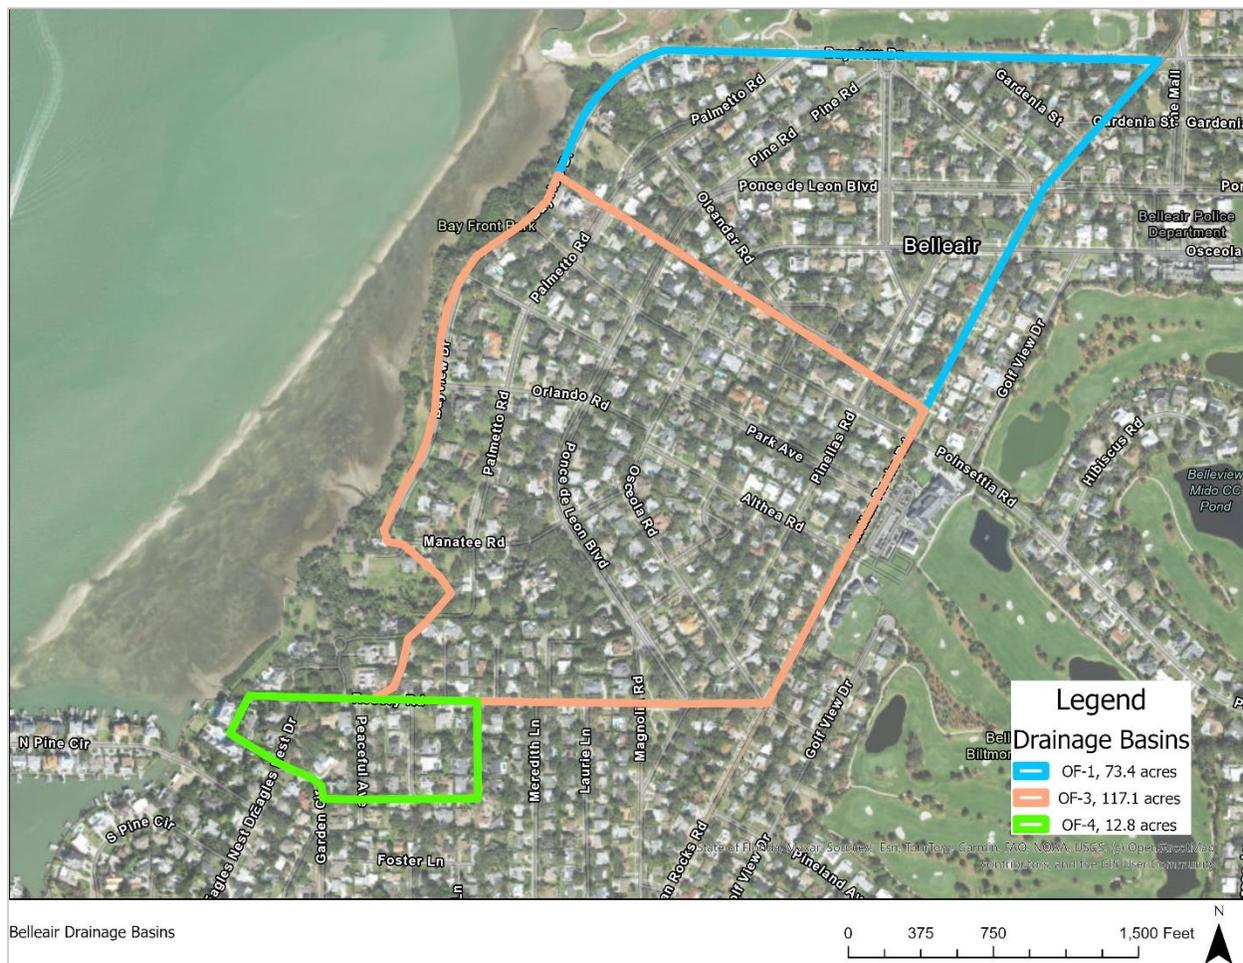
Figure 40. Stormwater Outfall Conceptual Catchment Basin Delineation.

OF-1 catchment included golf course (0.1 acres) as a land use category and was removed from the analysis. The mean annual rainfall was estimated as 52 inches. The non-DCIA curve number was estimated as 57 based upon an analysis of DCIA obtained from NOAA satellite imagery. The specifications for each proposed BMP were input as indicated within the design plans (see **Section 4** and **Appendix A-D**). The modeled conceptual nutrient reduction associated with each proposed BMP was calculated using BMP Trains V. 4.2.3 (**Tables 18-22**). The BMP Trains software report for each modelled scenario is provided in **Appendix K: BMP Trains Output Reports**.

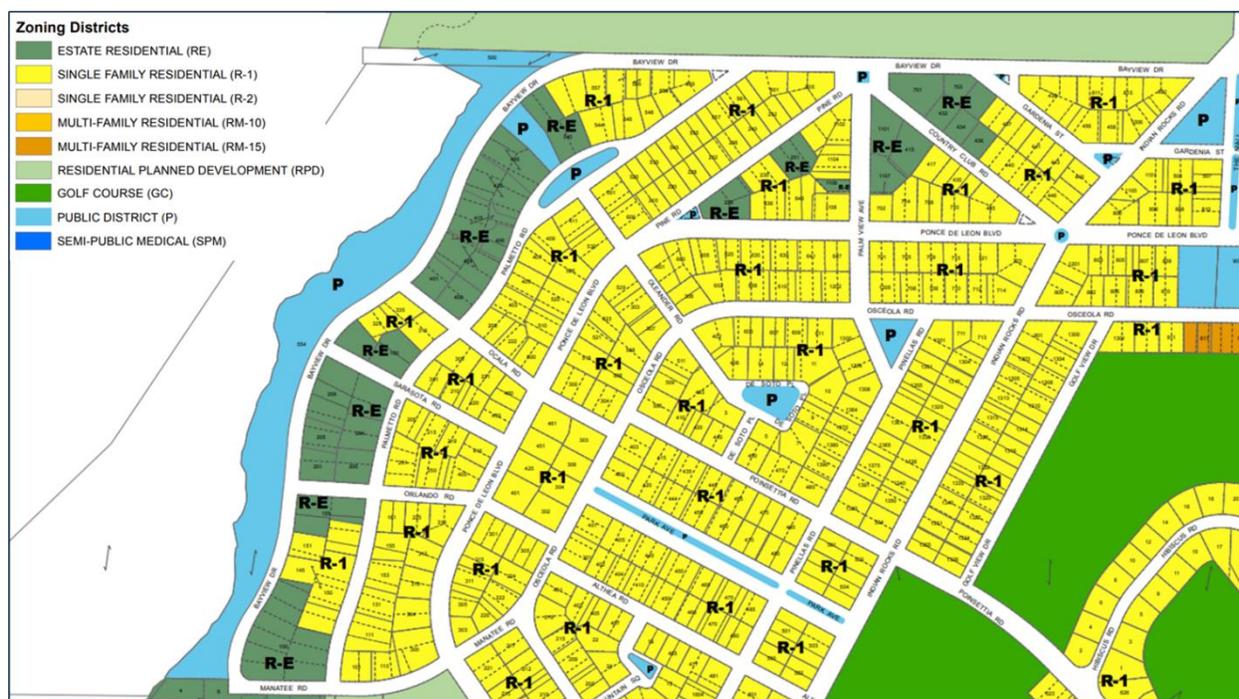
Figure 42. Town of Belleair 2018 Official Zoning Map

While there is limited space in the study area to utilize stormwater retention systems to manage pollutant loading, there could be such opportunities upstream. **Figure 42** illustrates the Town of Belleair 2018 Official Zoning Map, showing public land (in blue) that could be used as stormwater detention/natural depression. **Desoto Place cul-de-sac** could specifically be of interest as a natural depression area.

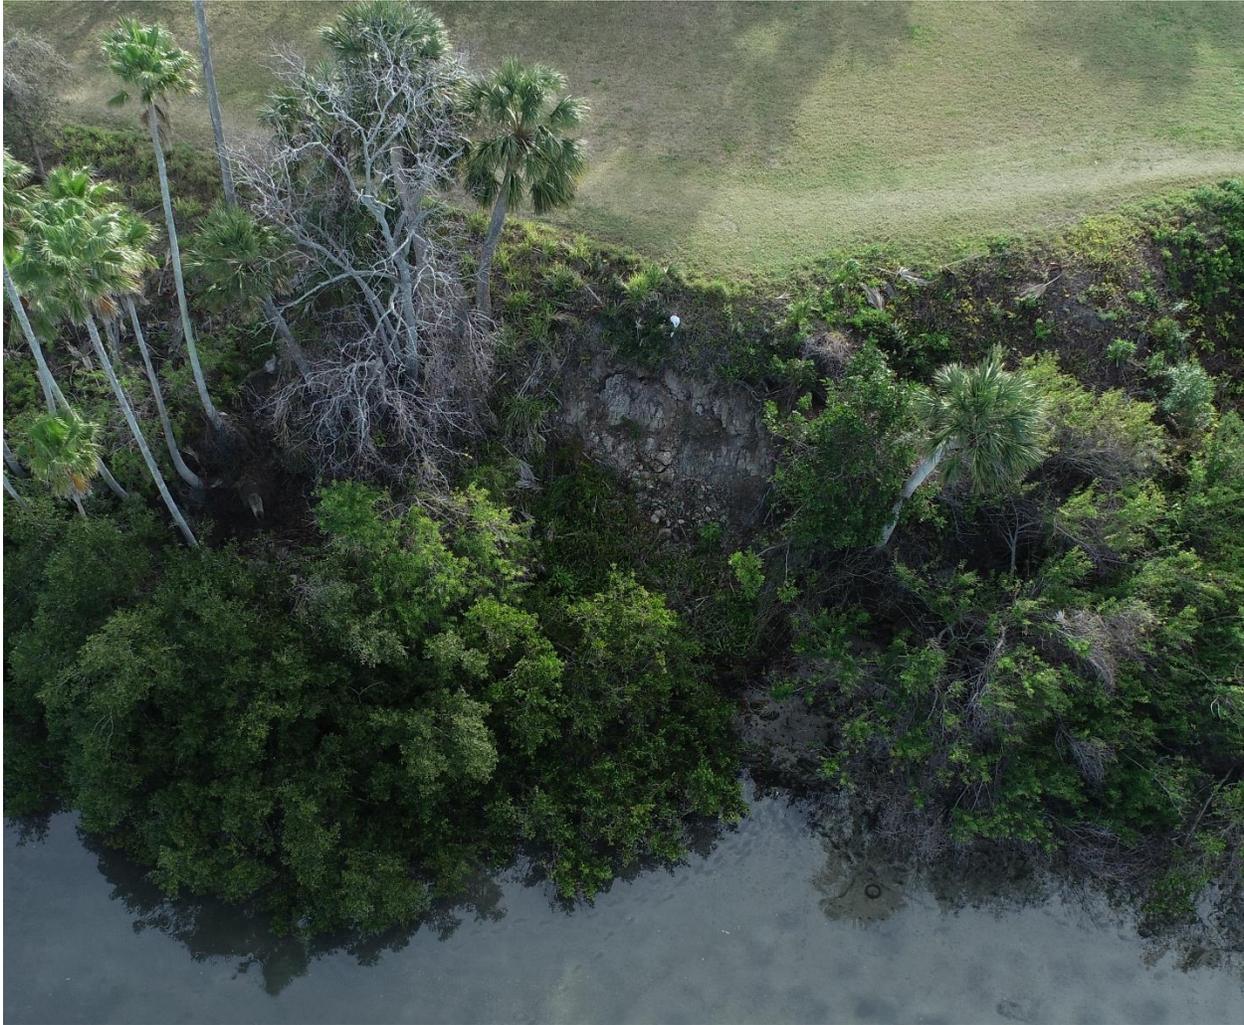
Figure 43: An example eroded section of the bluff with vegetation loss (Drone imagery credit: APTIM)

The Belleair project area, encompassing the Hallett Park shoreline along the interior of the Intracoastal Waterway between R-monuments R-60 and R-64, has faced significant erosion due to a combination of natural and artificial factors. **Figure 43** shows an example eroded section of the bluff with vegetation loss.
